**SURVEY REPORT #7158**

**Date:** January 27, 2021

**Vessel Name:** "EYRIE"

**Purpose of Survey:** Condition and value for pre-sale purposes

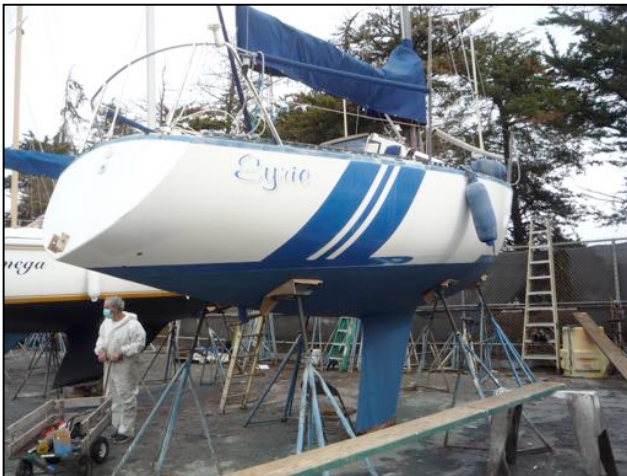
*View of starboard quarter*

- The wetted surfaces were they were found sound with no evidence of osmotic blisters or delamination noted. The bottom was just re-painted with antifouling while in dry dock
- The topsides, decks and the superstructure are sound; the gel-coat is dull and oxidized
- The interior is simple and functional; it is clean and organized

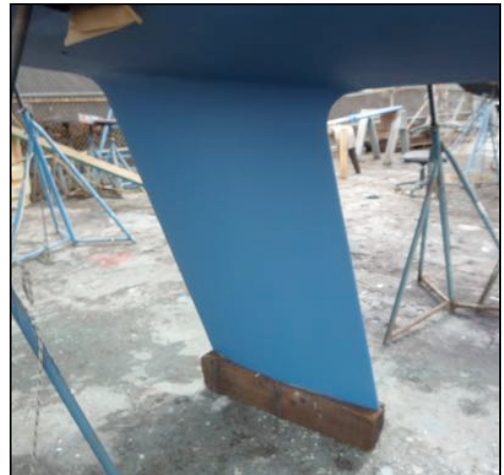
*Fin keel*

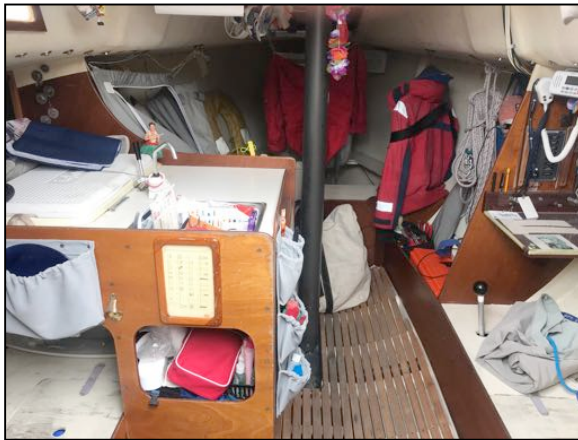
*View of interior*

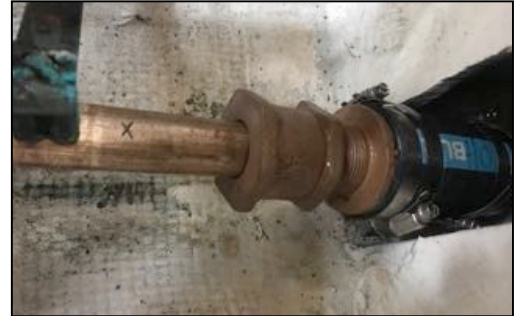
The cutlass bearing was just replaced, the stuffing box-repacked, the shaft log hose and clamps renewed and the folding propeller service

*Re-packed stuffing box*

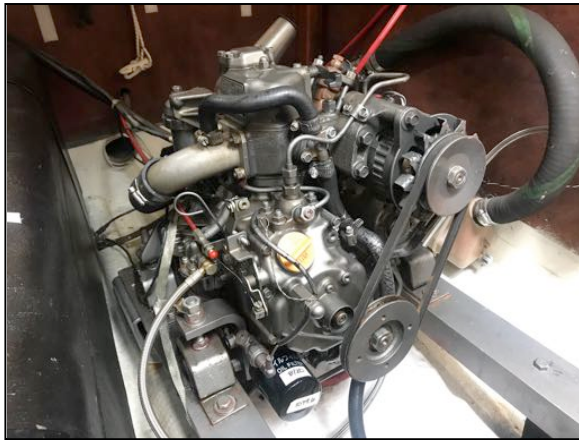
**Comments:** The engine was not run during this out-of-water survey. It was found clean and free of surface corrosion.

It appears well maintained; the last oil change was in August 2020 at 1079.6 hours.

*View of engine*

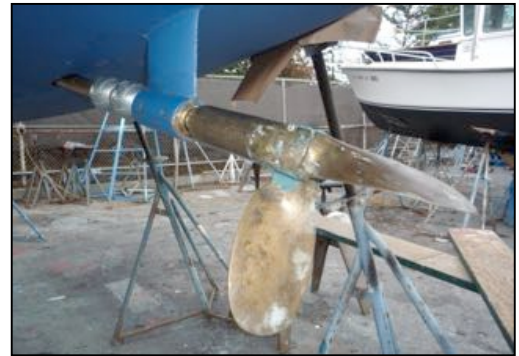
*Folding propeller*

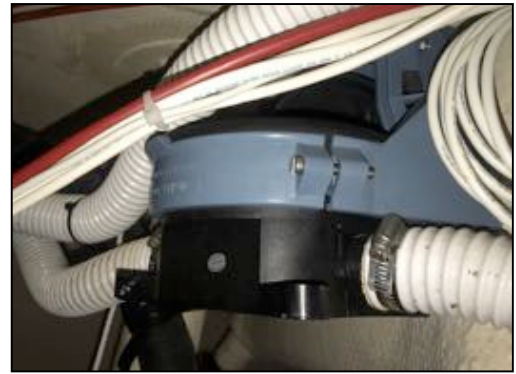
*One of two manual bilge pumps***ELECTRICAL SYSTEMS****Comments:** Overall satisfactory**DC System – 12V****Batteries/Amps:** - (2) KIRKLAND / 12V group 24 /flooded cell / 550 CCA, 750 MCA – dated 2011

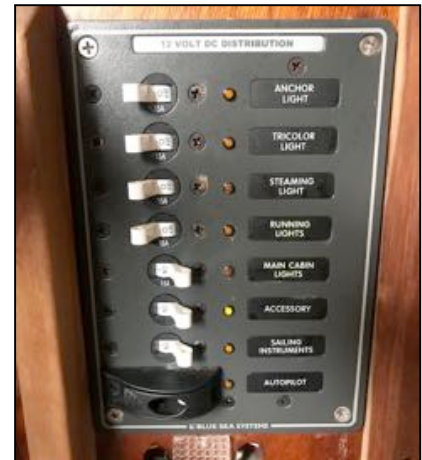
*Electrical panel***TANKAGE AND PLUMBING****Comments:** There is no fixed water tank installed**# Fuel Tanks/Capacity:** One / Est. 15 gals**Material:** Fiberglass**Location:** Engine enclosure, stbd side**How Secured:** Strapping**Accessibility/Condition:** Satisfactory**Fill/Vent:** Stbd cockpit coaming**Fuel Lines/Clamps:** Stainless steel braided hoses**Filters:** RACOR 50FGSS and secondary**Shut-off Valve:** At tank – seized (**Note**)

3. There are a couple of battery cable connections made with wing nuts, not to marine standards – recommend replacing the wing nuts with standard hex nuts
4. The spare battery is not secured – recommend strapping the battery to prevent any movement in excess of one inch
5. The steaming light trips its breaker when switched on – troubleshoot / repair
6. The running lights could not be verified in daylight – assure operational

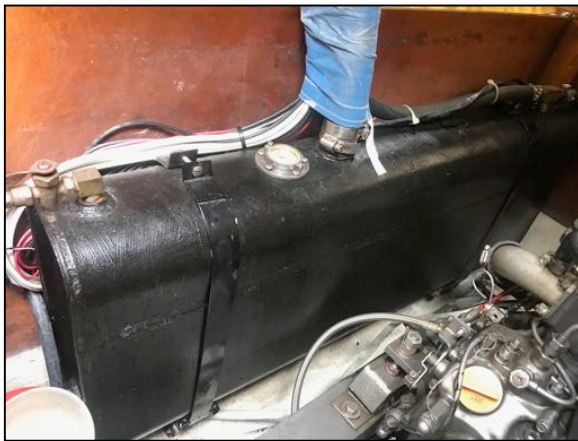
*View of diesel tank*

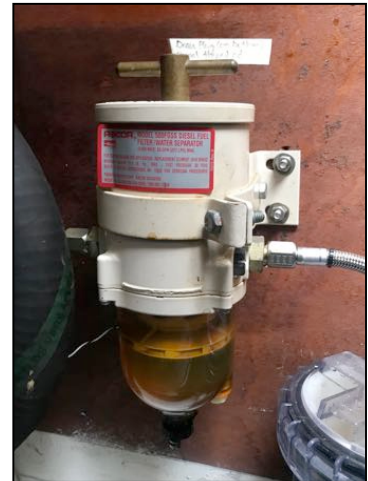
*Fuel primary filter***GALLEY EQUIPMENT****Comments:** Basic**Sink(s):** Single basin stainless steel**Refrigeration:** IGLOO portable cooler**Stove Type:** FORCE 10 single burner, gimbaled

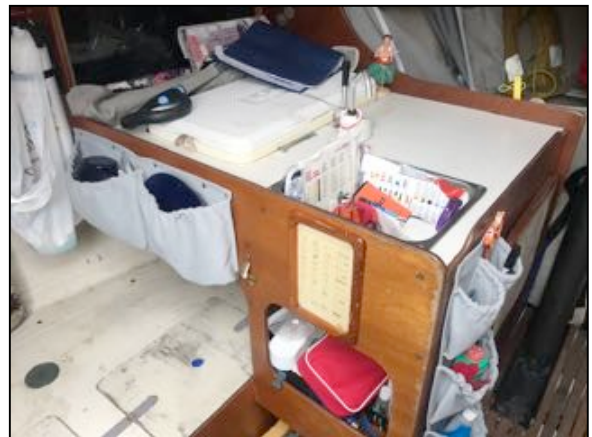
*View of galley*

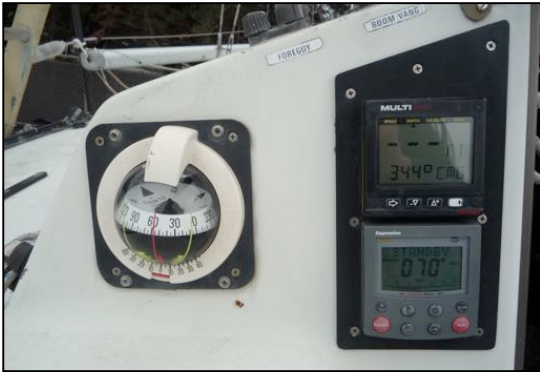
*Cockpit displays*

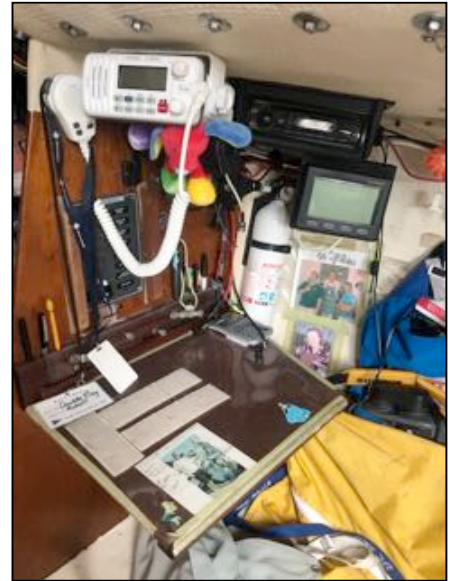
*View of nav station*

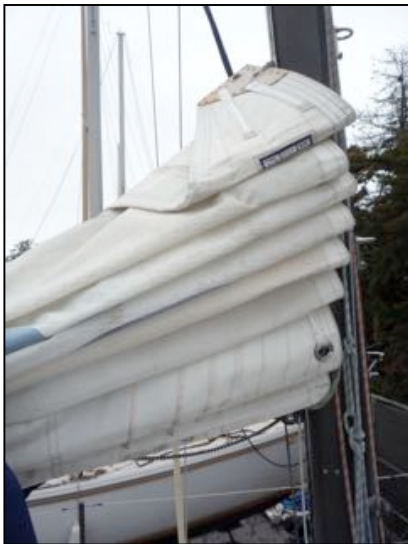
**Comments:** Most of the running rigging is tired and due for replacement

*View of flaked mainsail*

9. The running rigging is “tired”; the traveler control line is almost chafed thru – recommend renewing the running rigging as needed
